A Restoration Strategy for Swift's Ditch, Jasper National Park

**Prepared by: Cynthia Ball, V00297958
To Fulfill Requirements for: ER 390**

August 2010

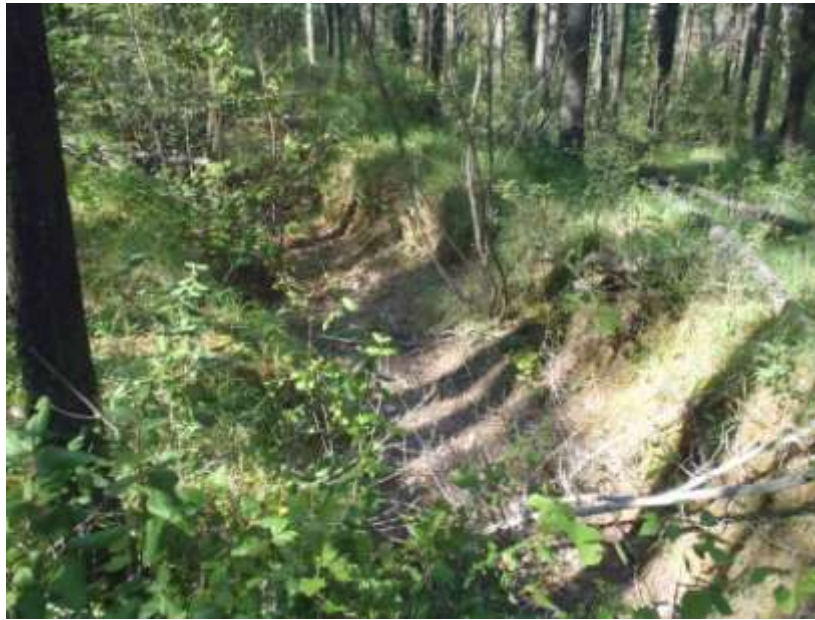
Figure 3: A Typical View of the Lower Section of Swift's Ditch

The substrate of the ditch's bank and bottom is primarily sand, with original reinforcement visible in places with sapling stringers. It appears that river rocks have been placed in the bottom of the ditch in some locations. The slope failure of the canal, or the blow out, occurs where there is a transition in gradient, where the canal descends escarpment slope and encounters the valley floor.

Swift's Ditch measures approximately 1.5 m wide but ranges from 30 cm to 4 metres in depth. The canal runs for several hundred metres, paralleling the base of the Palisades escarpment, to deliver water to what was once an agricultural field at the Palisades Centre.

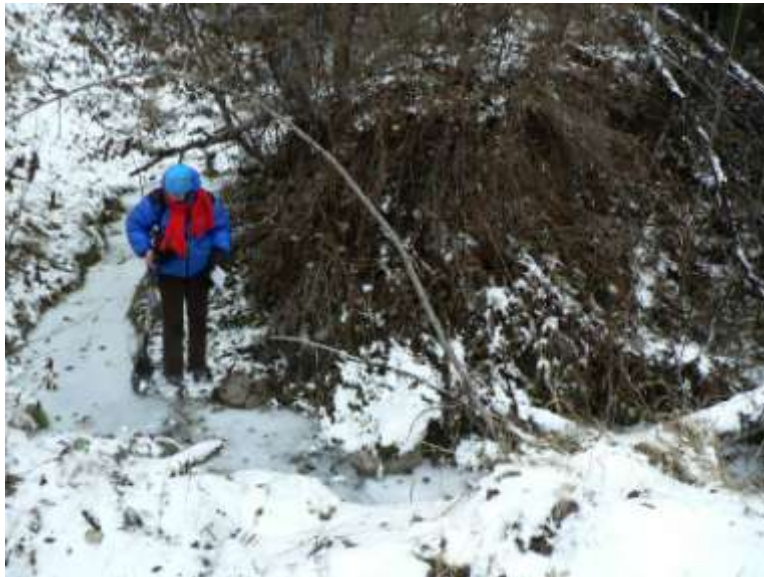
Figure 4: Breach of Swift's Ditch—ie. the Blow Out (2009)

A factor contributing to slope failure at the location of the blow out, is springtime retention of an ice plug, caused by differential thawing with the shading of several large spruce trees. Water flows over the sandy bank of the canal causing rapid erosion. When the canal breaches, the creek waters attempt to re-establish their natural drainage course, in a northeasterly direction. The original drainage course can still be traced, as a subtle intermittent meandering depression, with periodic exposure of its' rounded cobblestone bedding. From local topography and direction of flow, the former streambed is presumed to have drained to the nearby Athabasca River.

5. Although the ditch has been breached again since the repairs in 1998, ie at the "blowout", the road has not been flooded. Since repairs in the area of the blowout have not been successful in the past, re-establishing the flow to the lower portions of Palisades Creek should be considered. Flooding across the road only occurs during extreme discharge periods. This only occurs after the entire low laying Aspen stand has been inundated with water. Re-establishing the original creek flow would not change this process or increase flooding across the road. It would however, permit more regular flow of water to the stand on the northeast of the pipeline.

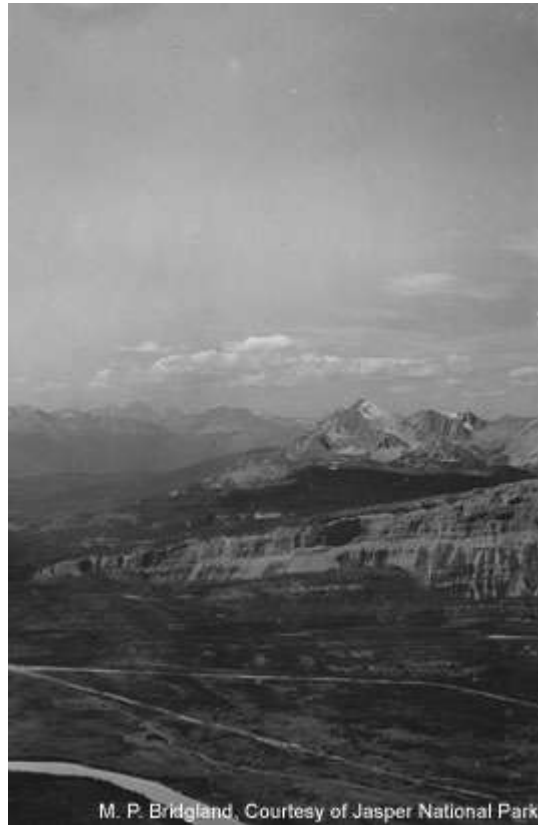
Figure 6: 1915 Bridgland Photograph of Study Area Including Both Railways and the Palisades Creek Catchment Basin (Courtesy of Jasper National Park, Station Name: Hawk Mountain; Station Number: 40; Photograph #318).

Unfortunately, Swift's Ditch is not visible in this or other Bridgland photographs because of the angle at which the photographs were taken.

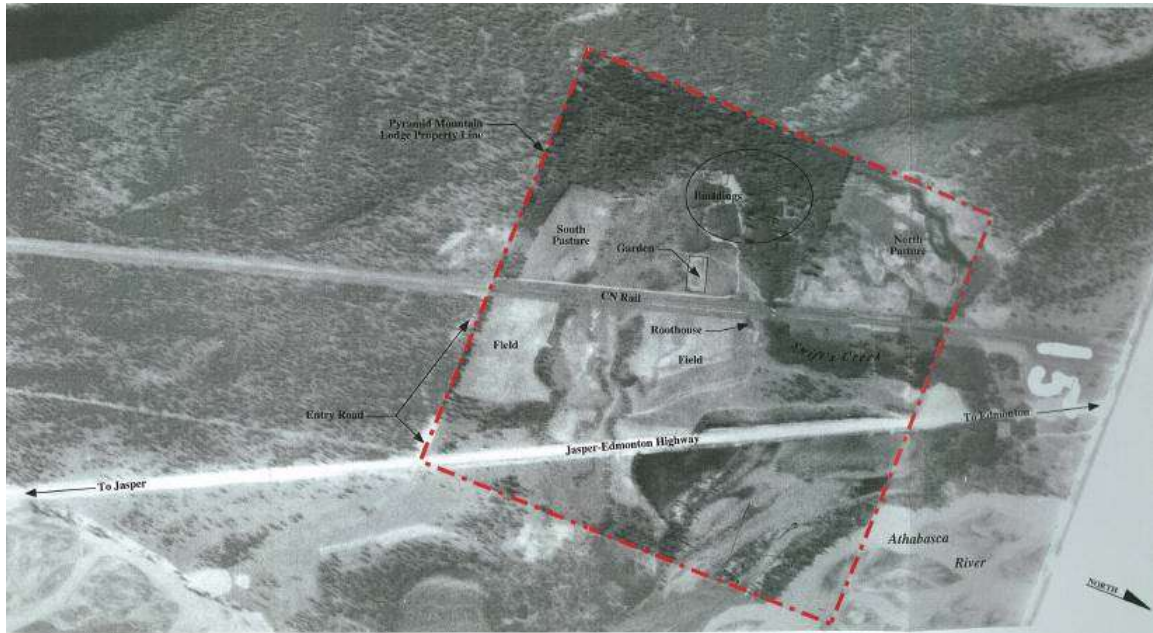
Figure 7: September 7, 1949 Aerial View of Pyramid Ranch Lodge (known today as the Palisades Centre) (Photograph Courtesy of Alberta Photo Services—Roll AS145 Print 52, 1:40,000 original scale)

It took from 1949 to 1952 to take aerial photographs of the entire province of Alberta (Sidney Wood, personal communication, August 2010). Historical records held by Kinder Morgan Canada indicate that planning, survey, and mapping of the TransMountain pipeline started in 1951 (Mears, email August 16, 2010). Therefore, the fresh scar to the west/northwest of the north pasture appears to be Swift's Ditch.

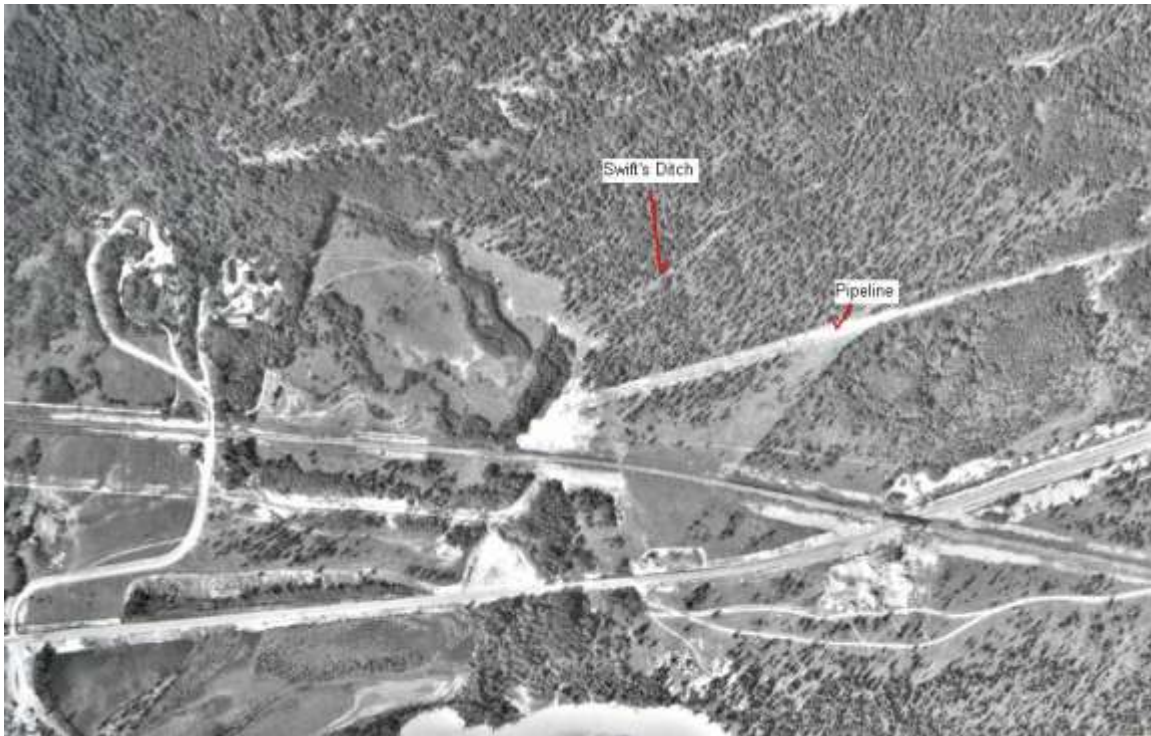
Figure 8: 1958 Aerial View of Palisades Ranch and Motel (known today as the Palisades Centre) (Photograph Courtesy of Alberta Photo Services—RollA16083 Print 116, 1:40:000)

The location of Swift's Ditch is clearer when comparing the 1949 aerial photograph to the 1958 aerial photograph taken after the construction of the pipeline (figure 8). The TransMountain pipeline is clearly visible as is the irrigation ditch, in the 1958 aerial photograph.

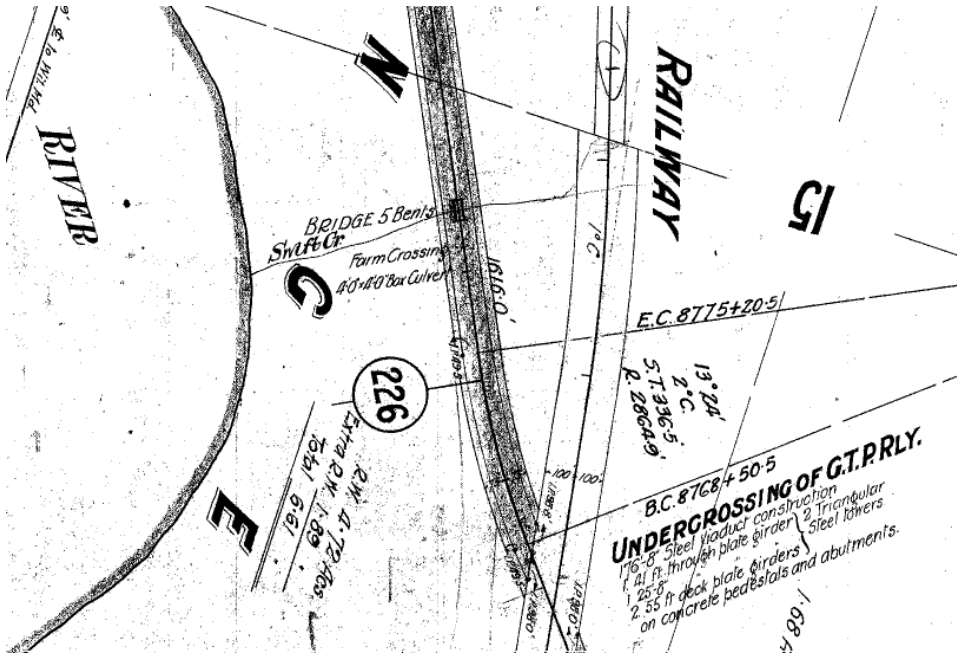
Figure 10: 1918 CNR Construction Plan—note Swift Creek. Swift’s Ditch is not shown.

A 1918 CNR Construction plan (figure 10) also shows Swift's Creek but not Swift's Ditch.

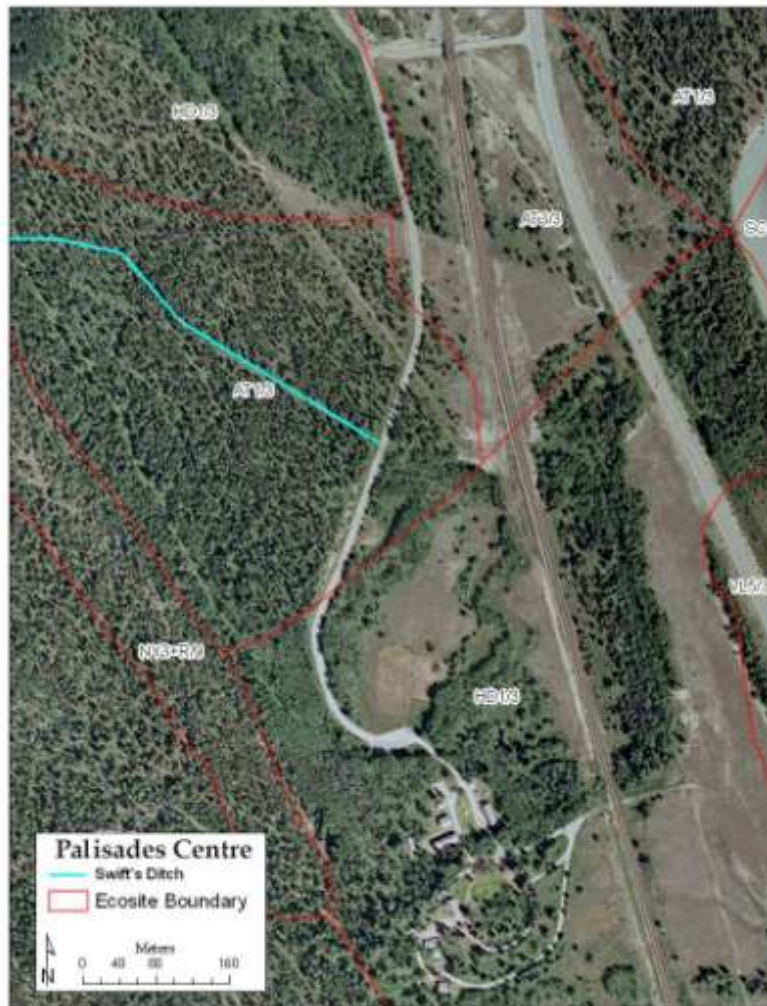
Figure 11 showing the Ecosite boundary

Swift's Ditch is located in the AT1/3 ecosite (the Athabasca ecosection). The AT1/3 ecosection encompasses terraced landforms of calcareous glaciofluvial material in the montane ecoregion with a 0 to 5% slope. The AT1 ecosite is found on floors and the lower benchland of broad valleys with a gentle gradient that accommodated large volumes of glacial meltwater (Holland, 1982, p. 174).

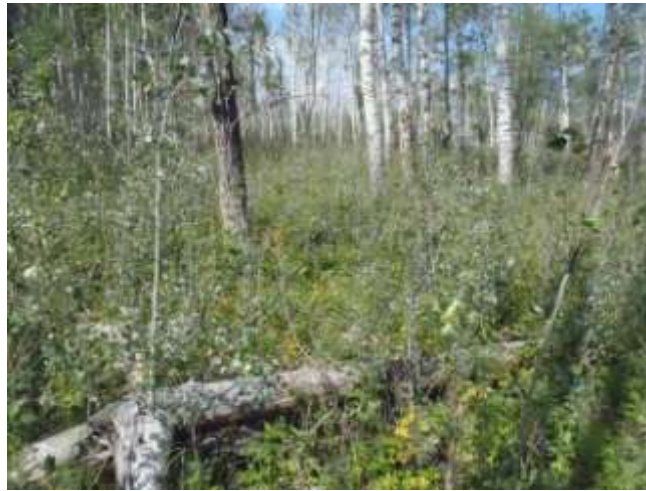
Figure 12: Vegetation in the Water Impeded Area, Northeast of the Pipeline

This area was burned in a prescribed fire approximately 10 years ago. All Balsam poplar are dead in this stand. The ground is dry, however it looks like it is moist for a portion of the year. Clover is present throughout the stand, and there are thick patches of mustard along the pipeline.

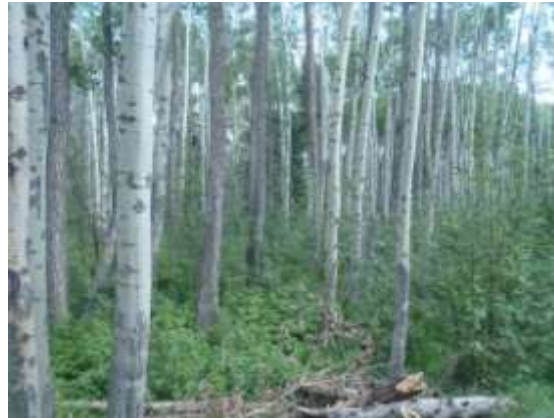
Figure 13: Vegetation in area of non-impeded water flow, northwest of the pipeline

Approximately 50% of this area appears to receive standing water as indicated by floatsam debris, moist and wet, open ground. The original channel for Palisades Creek is moist, there is no vegetation growing in it and it appears to have some water in it annually. The forest stand is approximately 80% Aspen and 20% Balsam poplar, which is concentrated along the original Palisades Creek channel, although they are found throughout the stand. The ground is dominated by leaf litter.

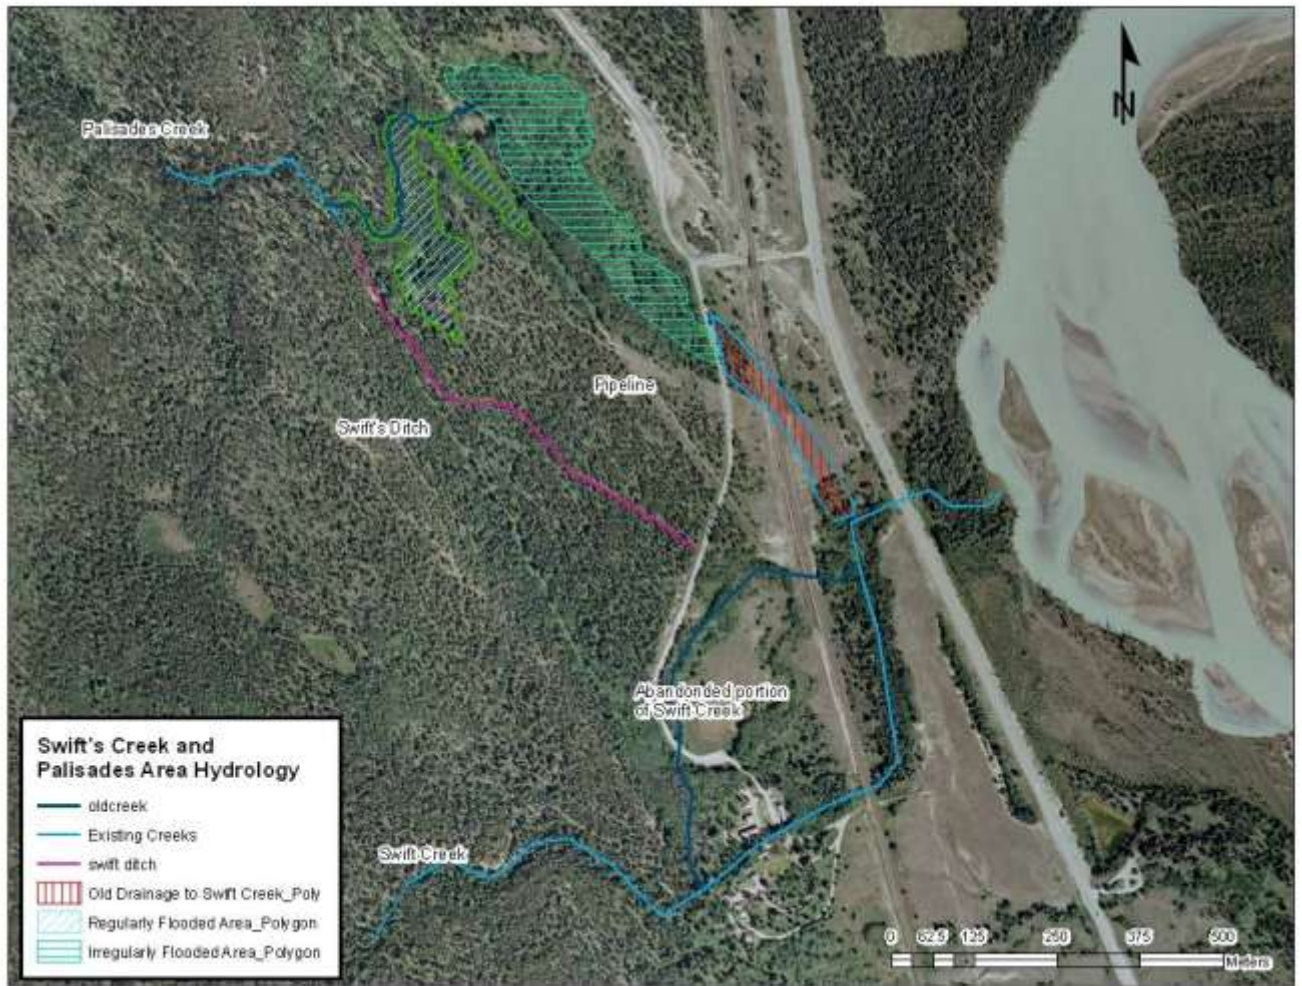
Figure 14: Swift's Creek and Palisades Area Hydrology

Figure 14 is a visual representation of the following data which was recorded using a GPS device:

Palisades Creek was redirected (at N 52° 58'16.7" W 118° 04'03.4") into a manmade ditch, commonly called Swift's Ditch (see figure 14). The original creek flowed into the flatter study area at the base of the Palisades cliff where water flow is non-impeded. Within the study area, the creek is a 50cm deep channel, with an extensive surrounding flat area. Flood conditions would result in this flat area being inundated with water. A breach ("blowout") in the Swift's Ditch (at N 52° 58'13.4" W 118° 04'00.2") presently allows the creek to drain into this same flat area. There is a pond here where there are 1m high watermarks on the trees.

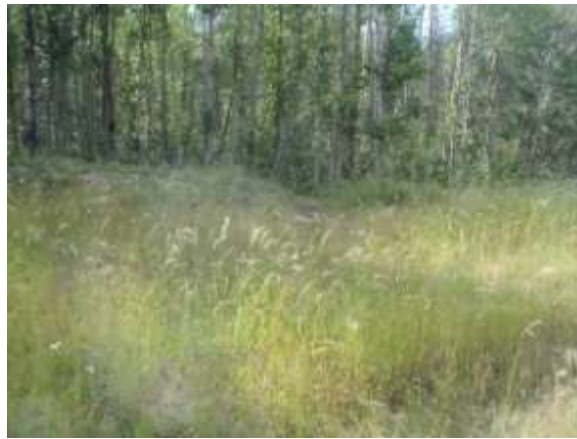
Figure 16: Showing the location where Palisades Creek (dip in the slope) meets the pipeline

During high water levels the original Palisades Creek in this lower flat area, fills with water and drains towards the pipeline. The pipeline is raised up approximately 1m above the surrounding terrain and has impounded the Palisades Creek. The creek water has made it out onto the pipeline, resulting in a small, eroded drainage area.

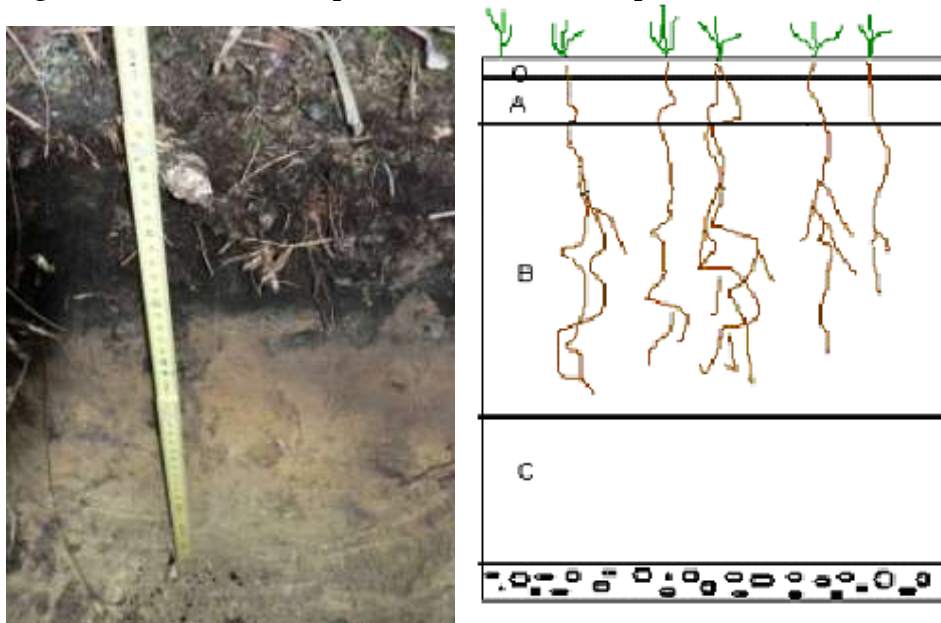
Figure 17: Pit # 1 Aspen Stand – water impeded area

Horizon	Depth	%Sand	Ribbon	Feel	Taste	Texture
Of	0–9 cm					litter organics, moss
A	9–22 cm	0	thick, breaks	not grainy	no sand	dark organic soil with roots
B	22–32 cm	0	thick breaks	not grainy	no sand	dark brown with leaching
C	below 32 cm	>50%	none	v. grainy no flour	sand	sand and gravel

This is a flat area that has flooded in the past. The Biophysical Land Classification describes typical soils in the ecosite as Brunisols. However, the soil pit indicates more of a Gleysolic soil, which is often associated with fluvial landforms.

The soil pit within the water impeded area (NE of the pipeline) indicated that the soils there developed in an environment with regular litter accumulation and decomposition, moist but not saturated, and with little disturbance. It is consistent with the slightly depressed topography, somewhat regular water accumulation and deciduous forest with a thick understory.

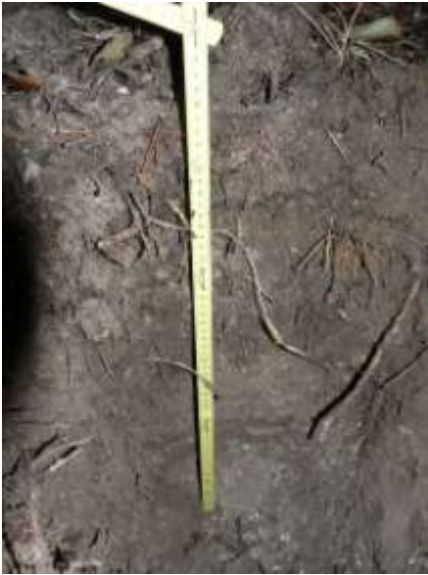
Figure 18: Soil Pit #2 Palisades Creek side, upstream of Swift's Ditch

This uniformity of this pit indicates that there has been no digging or disturbance in this area. It also confirms the location where Swift's Ditch starts.
