# Arbutus Park:

A restoration prescription for an eroding urban shoreline

An ER390 project

July 28th, 2011

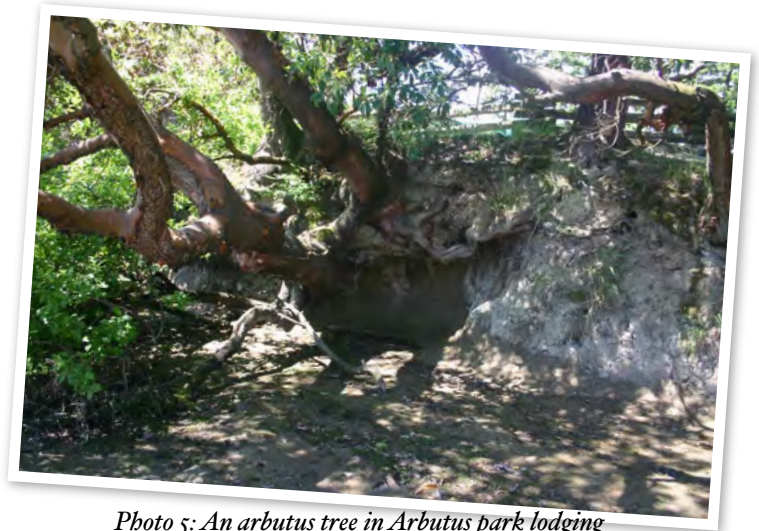
Photo 5: An arbutus tree in Arbutus park lodging under extreme erosion

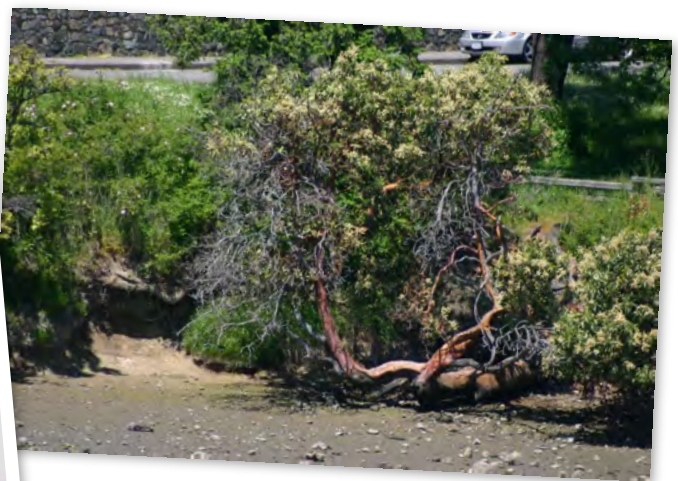
*Photo 6: Arbutus tree fallen over into the waterway*

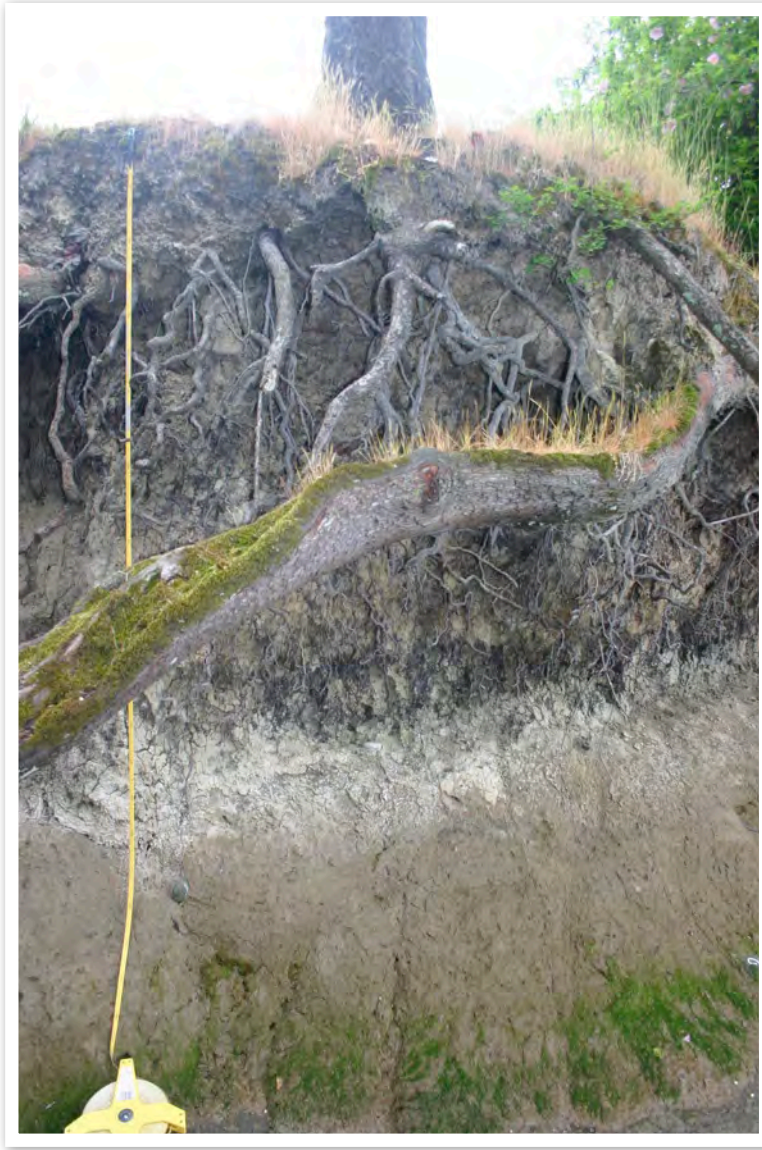
*Photo 7: Exposed soil layers on eroded bank of Arbutus Park*

The upper, or 'a' horizon, of the park's soil is inconsistent. In some places along the shoreline it has been completely eroded away by pedestrian and pet traffic. In other places it is found to be up to 6 cm thick. The places where the soil remains are generally inaccessible due to the growth of shrubs. The b horizon is a silt/clay mix which is 1.8 m deep. The c horizon is a marine clay. Erosion is so extreme that the c horizon is visible.

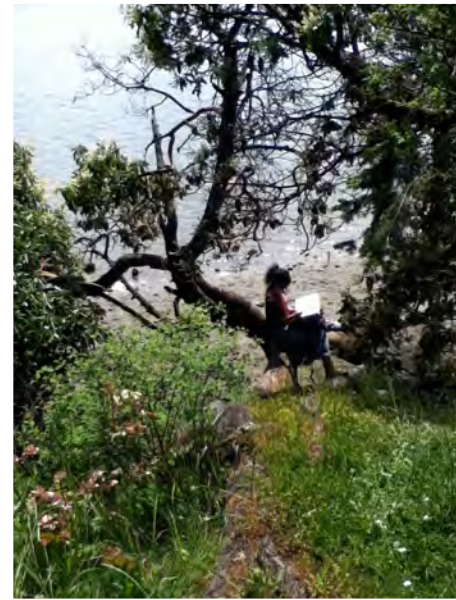
*Photo 8: Path on Southern side of Arbutus Park leading to fallen, but living, arbutus tree*

banks allow them. They make their own pathways down to the waters edge, some of which are not safe and all of which are harmful to the integrity of the parks banks [photo 8]. It is unlikely that their movements will ever be stopped, but the damage may be controlled to a level that precludes damage to the site by controlled access.

Stairs should be built, complete with a viewing platform, at the south end of the park to provide people with visual access to the mudflats and waterway. It should be made clear, via unambiguous signage, that people should not leave the platform for personal safety reasons and so as to not degrade the shoreline habitat. The reasoning for this suggestion is that people want access to the shoreline views and the privacy that the

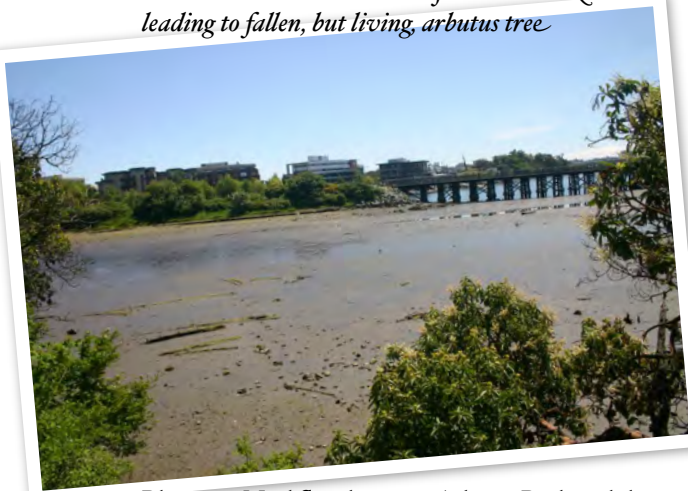
Photographs clearly show that this is resulting in massive erosion of the sediments in the estuary; erosion of the mud flats. With the erosion of the mudflats follows the erosion of the banks of Arbutus park as it is nature's way of regenerating the mudflats. But the loss to the City of Victoria parkland is great. Photographs 1 and 4 demonstrate that the distance that the land jutted out into the water, and the angle from which the shore slopes to the water has changed dramatically.

*Photo 10: Mud flats between Arbutus Park and the Selkirk trestle bridge*

Although the waterway is the jurisdiction of the CRD, it must be mentioned that the planting of appropriate vegetation in the intertidal zone will also buffer the shoreline of the park from erosion. The city of Victoria can help the CRD in these efforts. The City has staff who are trained in the techniques of establishing temporary barriers, such as anchored logs offshore, which can protect the transplanted vegetation as they try to establish themselves.

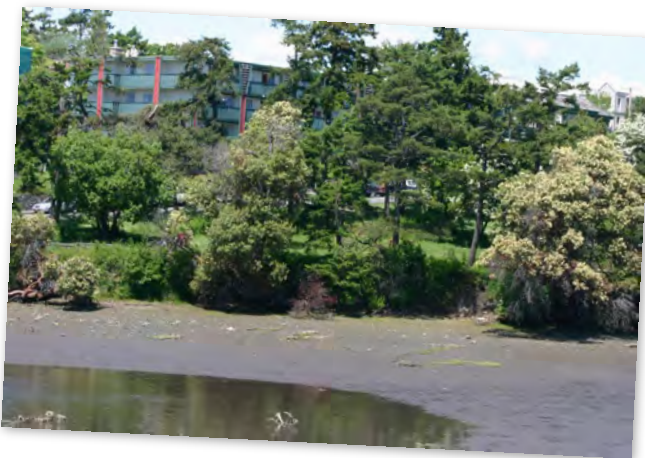
*Photo 11: View of Arbutus Park from the Selkirk trestle bridge*

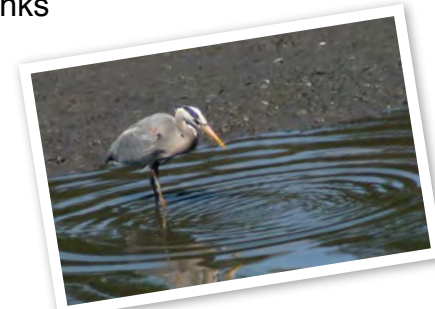
*Photo 9: Heron fishing on the mud flats beside Arbutus Park*

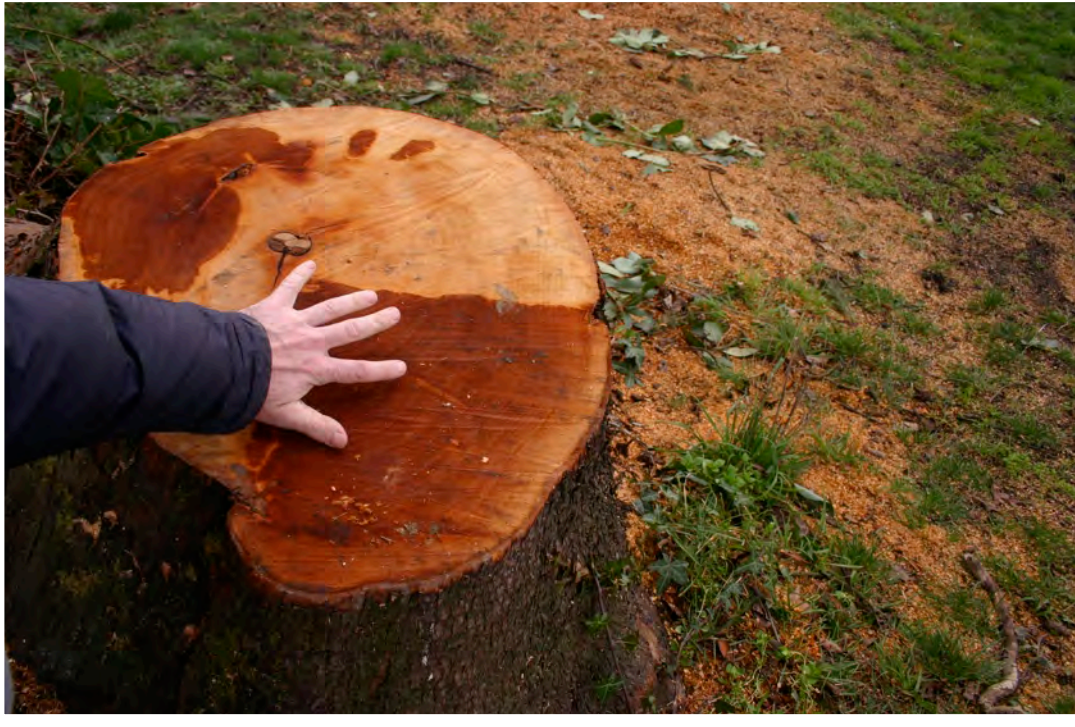
*Photo 12: Stump of the 120 year old arbutus tree cut by the City of Victoria Arbourist Crew.*

One of the cut down trees mentioned on page 18 (photo 12) that was removed by the Arbourist Crew of the City of Victoria was estimated to be 120 years old. That would mean that this is a tree whose existence was theoretically observed by Premier McBride. It was a tree that had survived the tidal wave of population growth in the area. This arbutus tree was (perhaps is, as it is trying to survive by growing shoots from the trunk) a living organism whose existence had been witnessed by 6 separate generations of human beings. It is a truly remarkable, as a human, to consider an organism of this longevity.

Within Arbutus park during the past 18 months, two arbutus, two firs and a cherry tree were seen to have been cut down by the parks staff. The wood was removed from the site. Concern about the removal of the trees was expressed to the author by a local citizen, as one of the firs was a favourite tree of the local woodpecker population. This makes one wonder if the wildlife value of the standing dead trees was assessed. Even if it was and the trees scheduled for falling, it would have been far better to strategically place the tree trunks within the park boundaries and maintain the biomass via the coarse woody debris.
