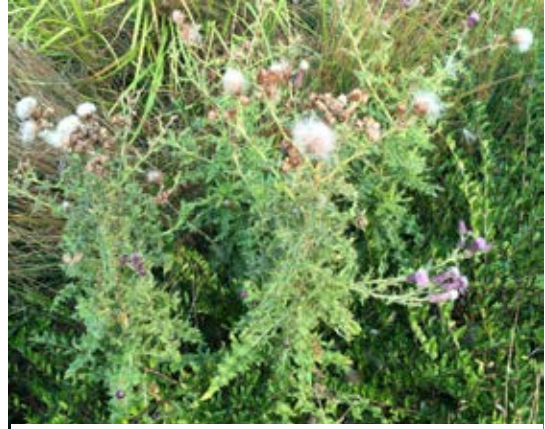
Figure 348. Canada thistle going to seed (Photo: Hebb 2018)

Aggressive, exotic plant species have invaded the garden since it was first planted. The dominant invasive species in 2016 was Canada thistle (*Cirsium arvense*) and this was still prevalent in 2018 (Kathrens & Jennings). See Figure 348 for a photos of Canada thistle going to seed along the outer edge of the pond. Additional invasive species include creeping buttercup (*Ranunculus repens*), general garden weeds, and curly dock (*Rumex crispus*). A few individuals of Himalayan blackberry (*Rubus armeniacus*) were also identified in 2016 (Kathrens & Jennings). See Figure 349 for a map of the distribution of invasive species in the rain garden and retention pond.
